SAm-1 cable Lessons from 14 years of operations

Telefonica Global Solutions

05.01.2014

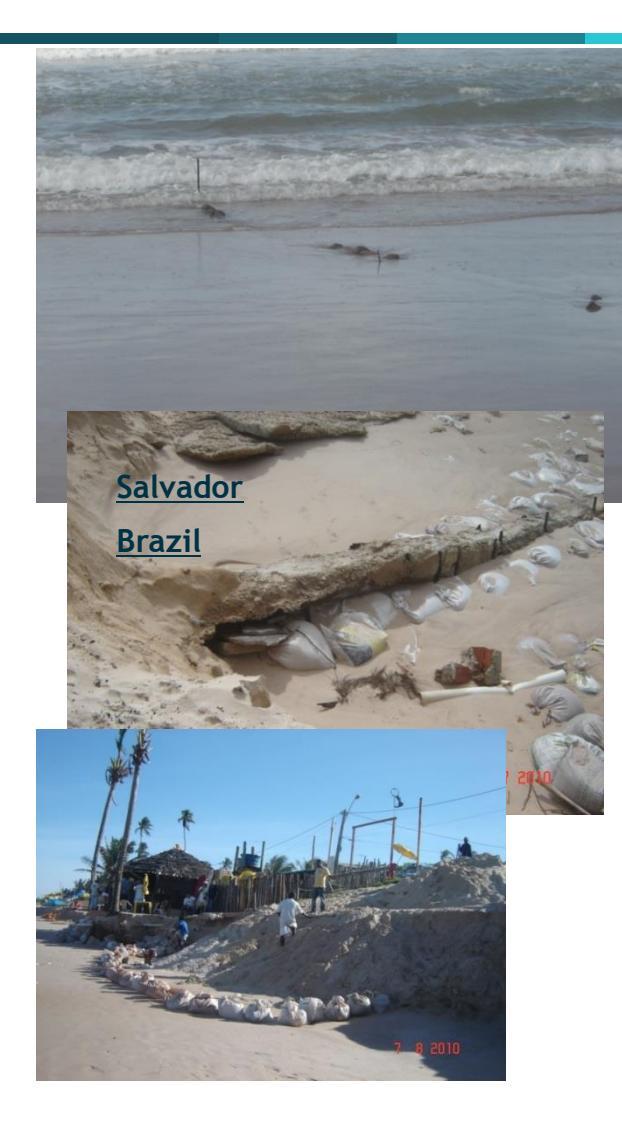
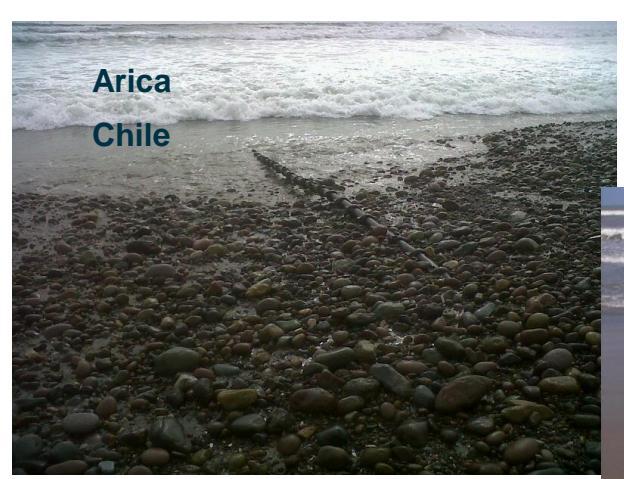
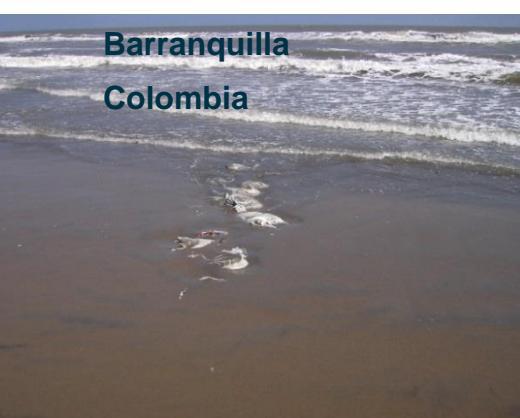
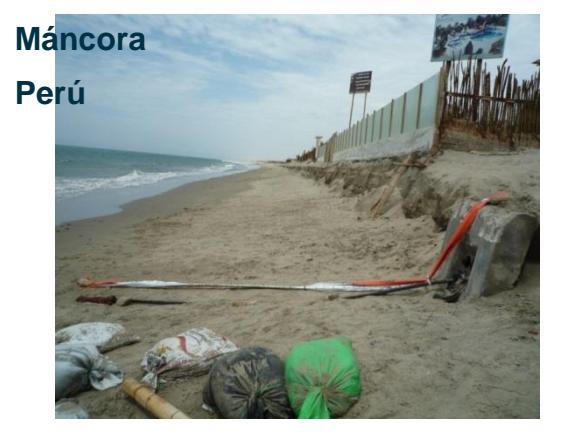
Snapshots of cable exposures

Topographic studies performed in the beaches that have suffered cable exposures

Divers post deployment inspection in 2012 to observe the cable 10 years after cable installation

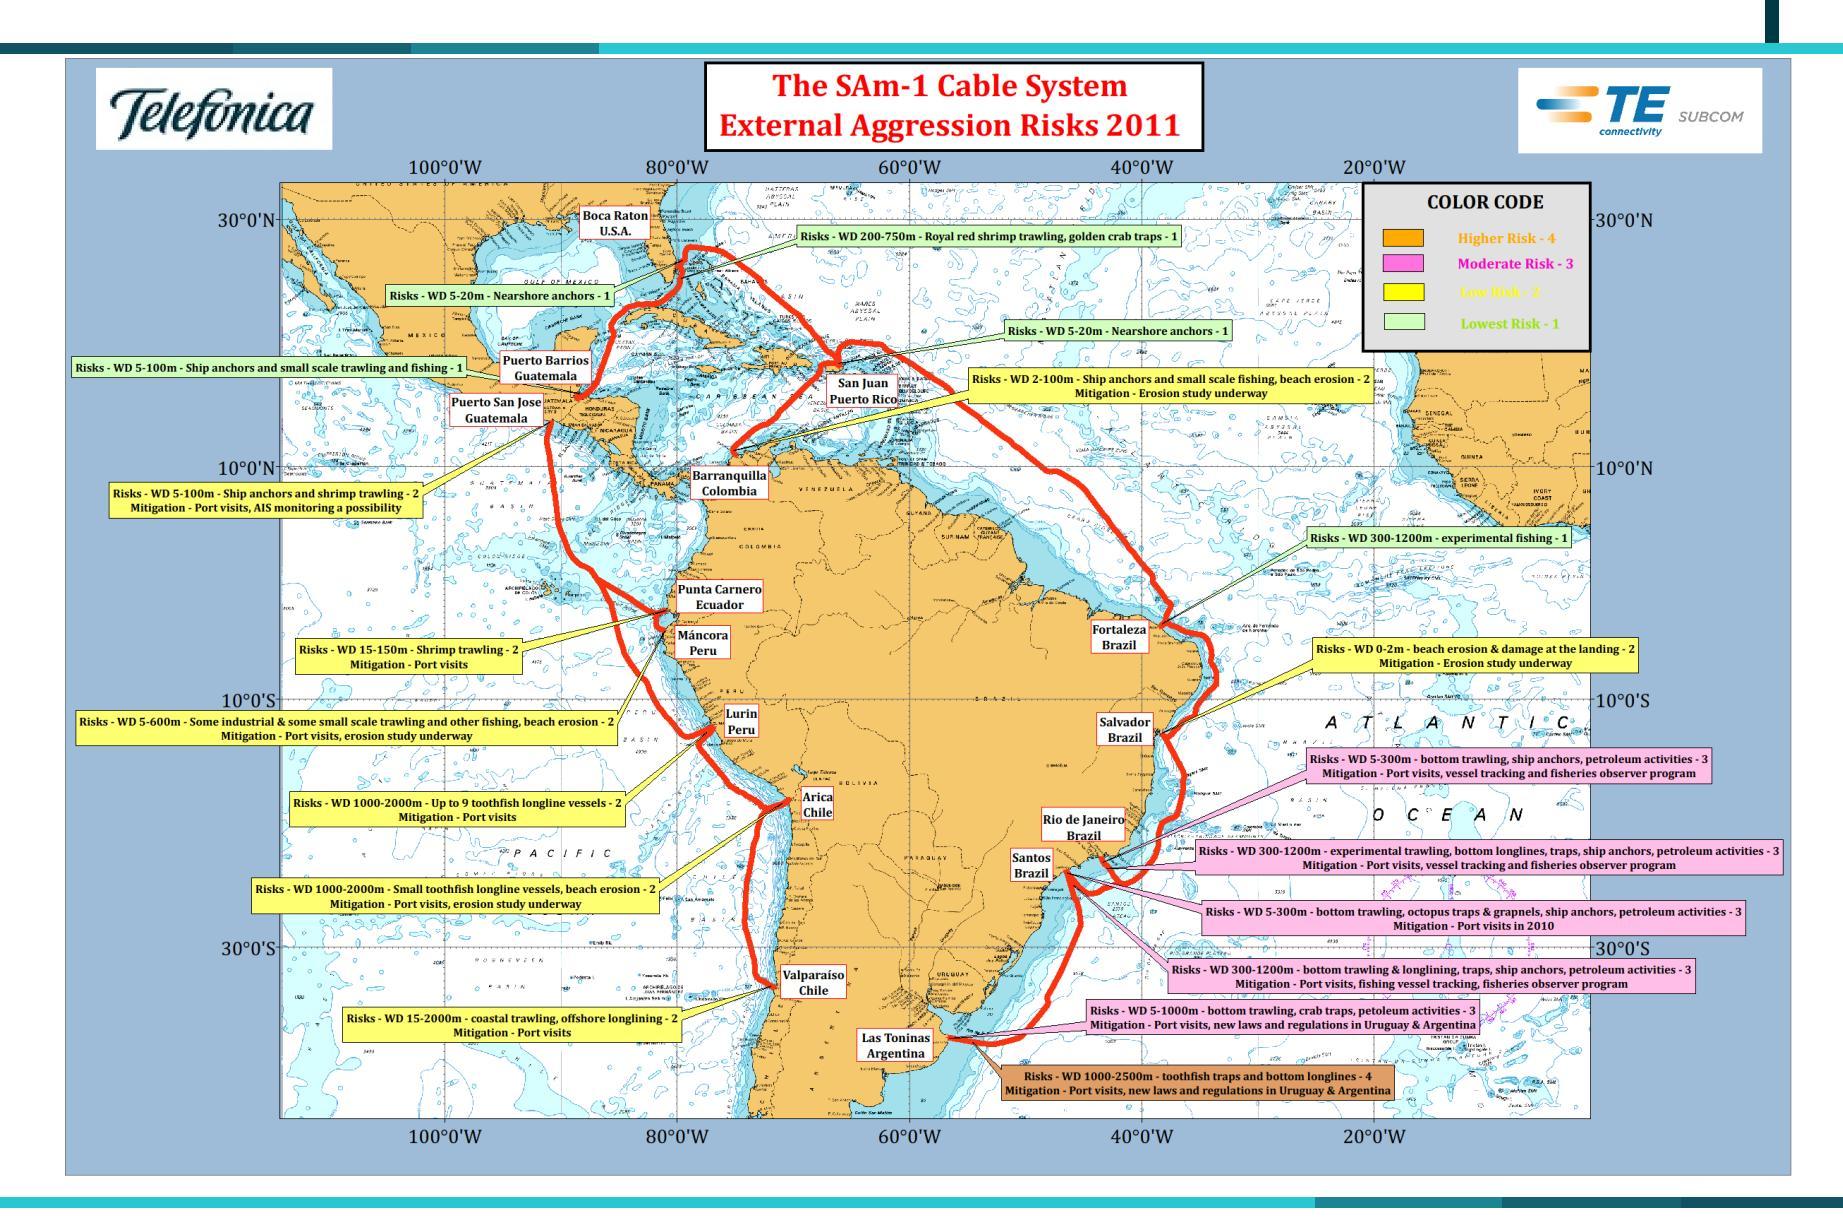
Conclusions of the actions helped to redefine the Risk Management Chart

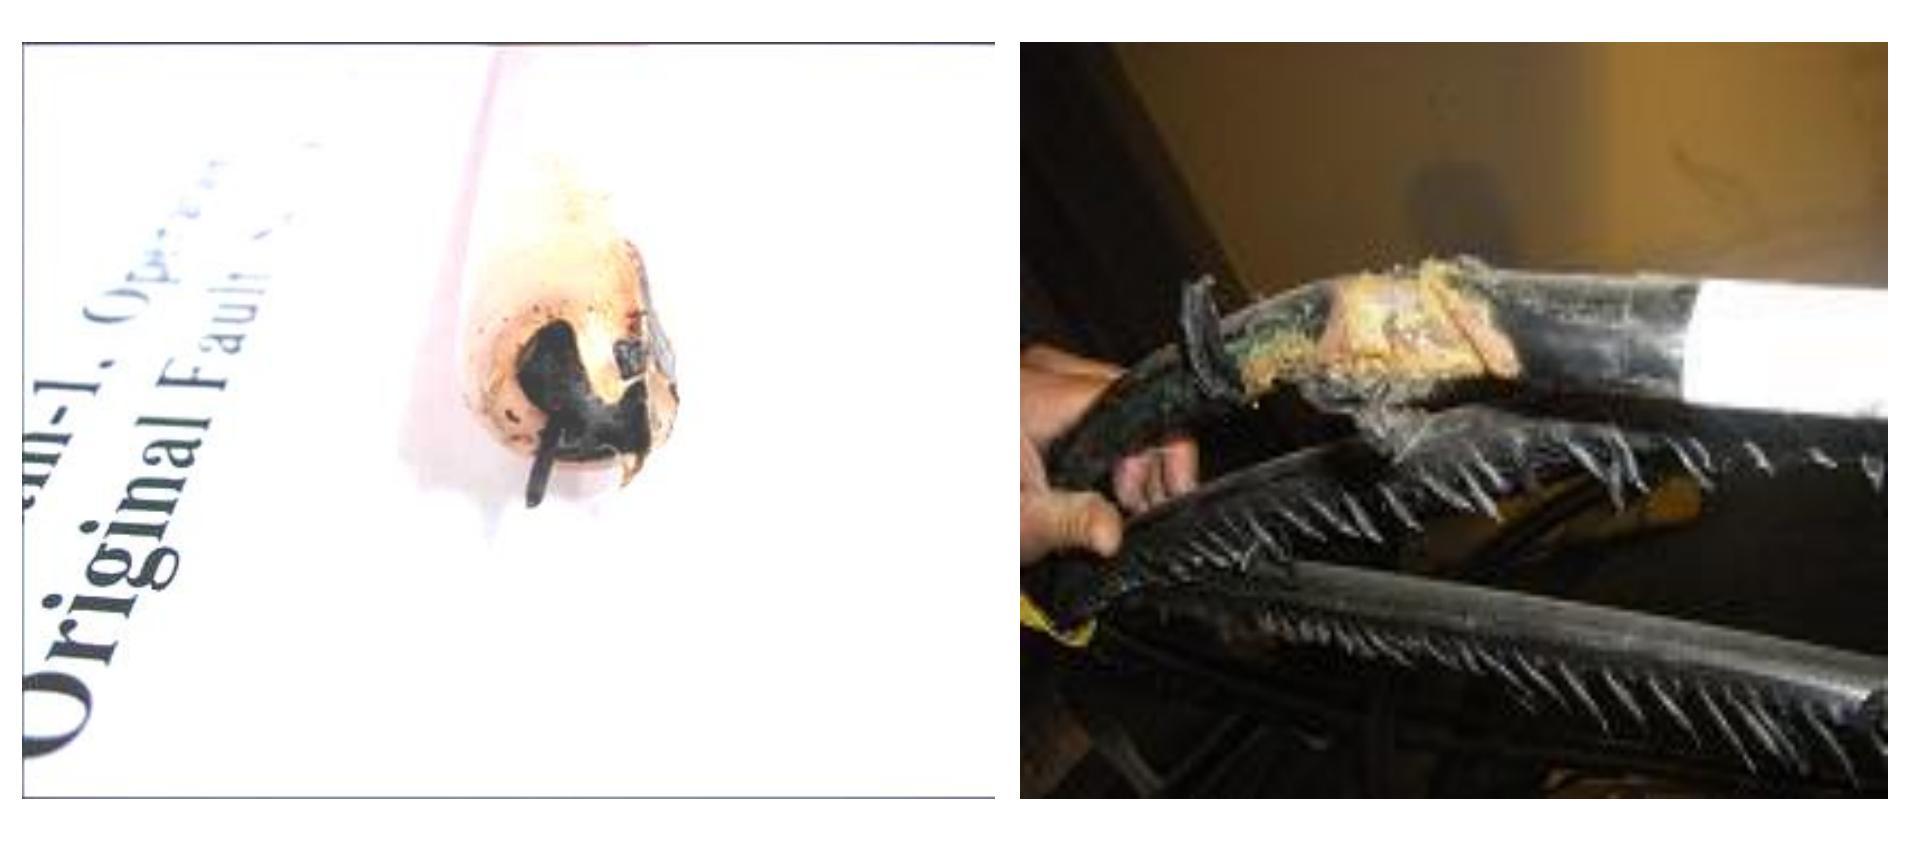
Faults

1ª Failure Segment D MAR 03

Type: Shunt Fault

Elapsed: 23 days Base Port: Montevideo

2ª Failure Segment A JUN 07

Type: Cable cut Elapsed: 9 days Base Port: Montevideo

3^a Failure Segment D NOV 07

Type: Isolation failure Elapsed: 25 days Base Port: Montevideo

4ª Failure Segment A JAN 09

Type: Shunt fault Elapsed: 39 days Base Port: Baltimore

5ª Failure Segment K JUN 09

Type: Cable cut (earthquake) Elapsed: 17 days Base Port: Curaçao

6ª Failure Segment A AUG 09

Type: Shunt fault Elapsed: 74 days Base Port: Curaçao

7th Failure Segment G DEC 10

Type: Shunt fault (earthquake) Elapsed: 201 days Base Port: Curaçao

7th Failure Segment H APR 12

Type: Shunt fault Elapsed: 39 days Base Port: Curaçao

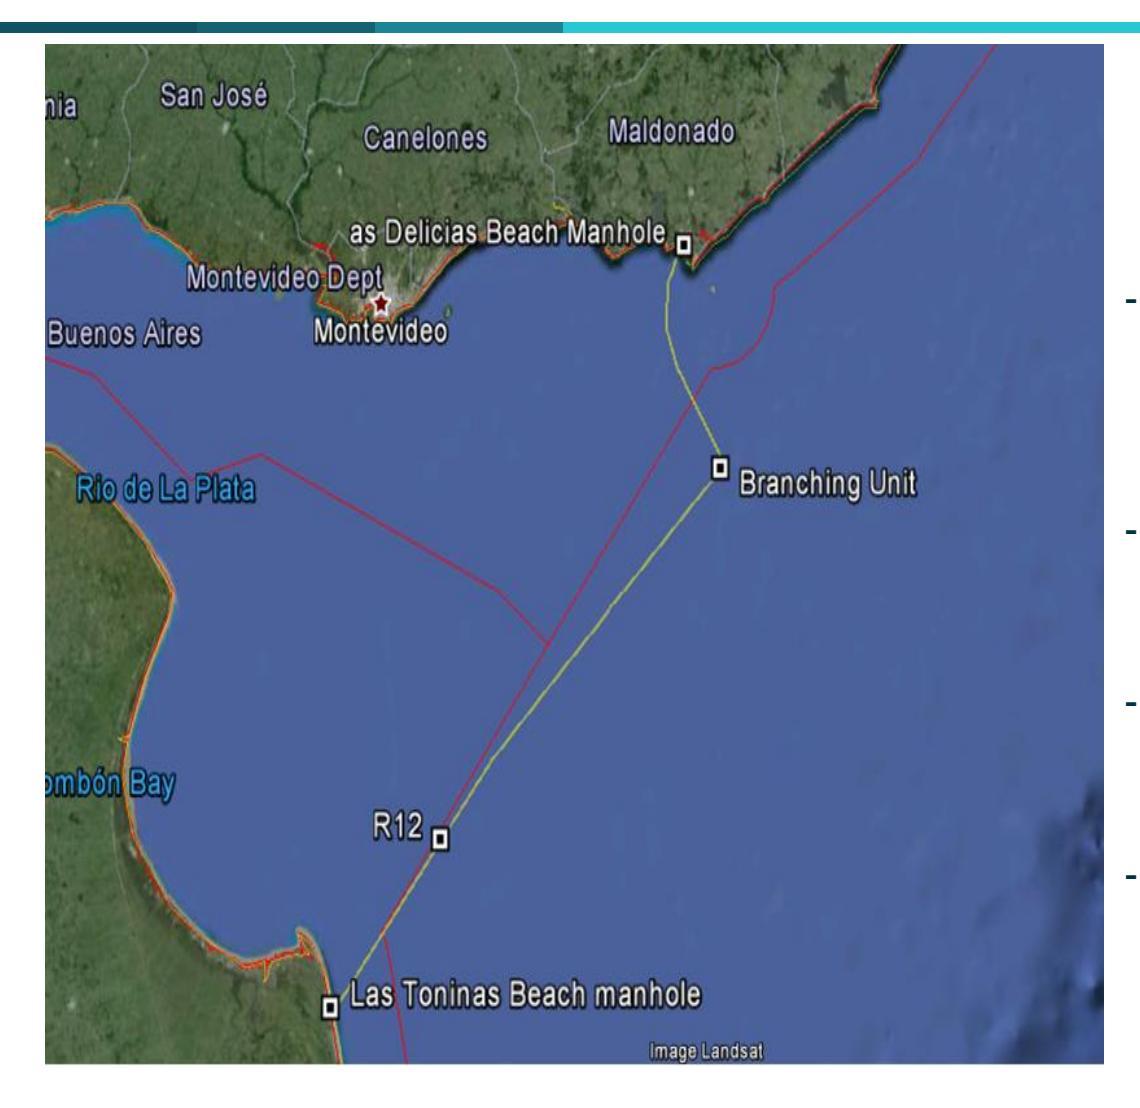
- Unisur started operation in 1994
- Testing and repurpose
- Back in operation 4Q2014
- Initial capacity 200 Gbps

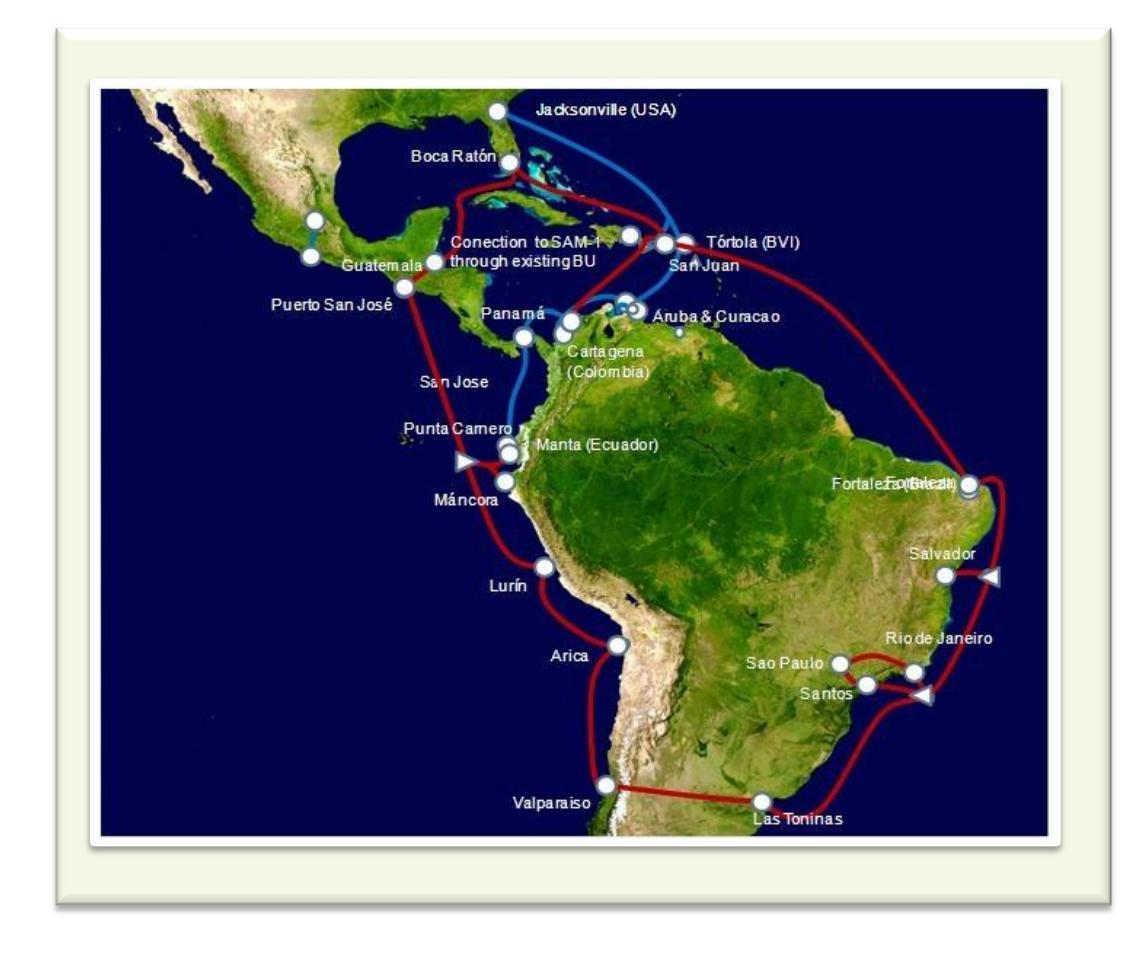
New PCCS submarine cable

- Jacksonville (Florida) New TGS
- Tortola (British Virgin Islands) -Existing C&W
- San Juan (Puerto Rico) Existing TGS
- Hudishibana (Aruba) Existing SETAR
- Cartagena de Indias (Colombia) -Existing Telefónica Colombia /TGS
- Maria Chiquita (Panamá) -Existing C&W
- Balboa (Panamá) Existing C&W
- Manta (Ecuador) New Telconet
